Geotechnical Study on Ground and Masonry Structures in Angkorfor Safeguarding Monuments( Dissertation\_全文 )

Iwasaki, Yoshinori

2001-11-26

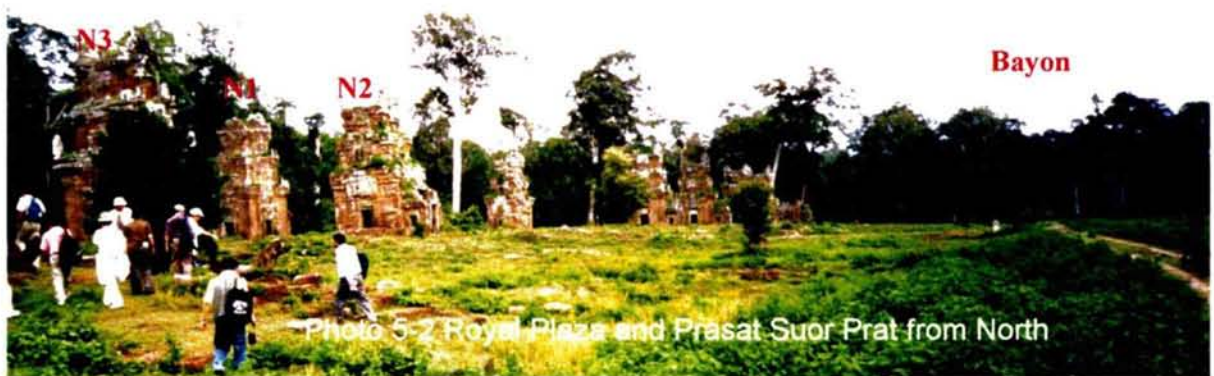
Fig.5-4 Results of Dynamic cone resistance near Prasat Suor Prat N2 and Royal Plaza

Top subsurface of 2 to 3 m is soft to medium clay. At the point (B.No.6) west of north library at Bayon, the penetration was rejected by laterite block, which may be a part of foundation system of the library. Some places (B.No.5 at Bayon and A.No.8 at North Library inside of the outer wall, Angkor Wat) showed softer characteristics than the average tendency. At Prasat Sour Prat, Towers are built upon filled material. The thickness of the fill is about two meters and is found soft ( $N_{dc} < 50$ ) in the layer less than 1.5m from the surface.

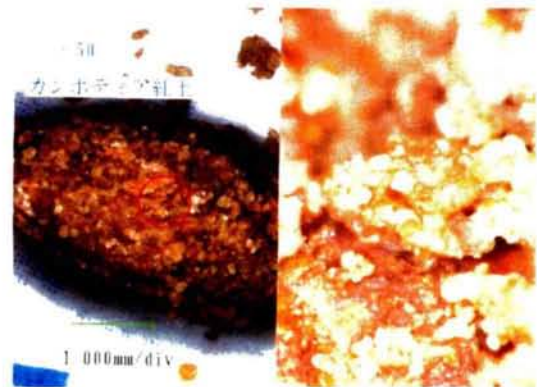
Photo 5-4 Lateritic soil

The surface soils are brown sand to silty or clayey sand. Generally, the color of the brown to reddish brown comes from iron oxides as shown in Photo 5-4.

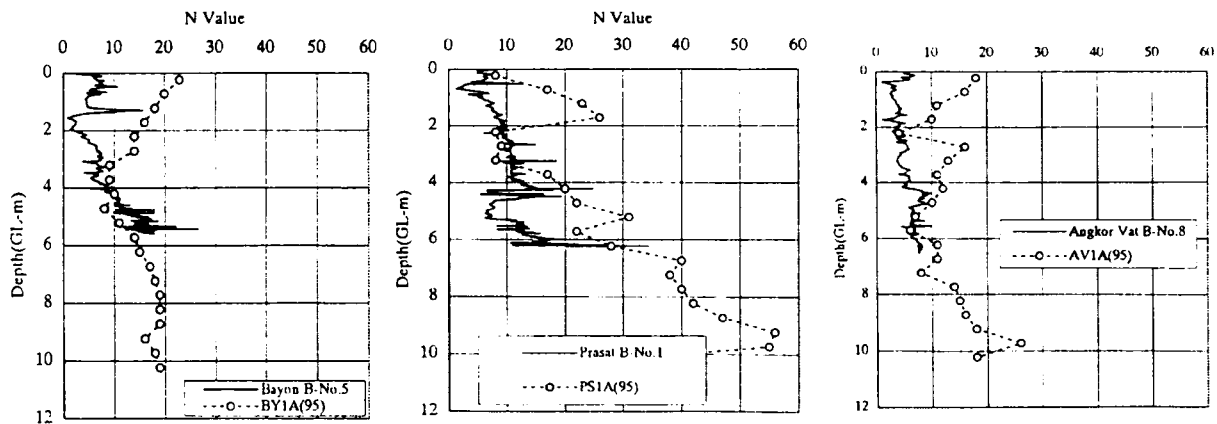
Fig.5-9 Comparison of SPT N-value (white circle/dry season) vs. Dynamic cone (solid line/rainy season)

The comparison between the SPT values against dynamic cone resistance number was shown in Fig.5-9. The dynamic cone resistances were converted  $N_{SPT} = N_{DC}/20$ . It may be concluded the surface will become hard due to desiccation of the surface during dry season. These effects are found down to 5-6m in the area.

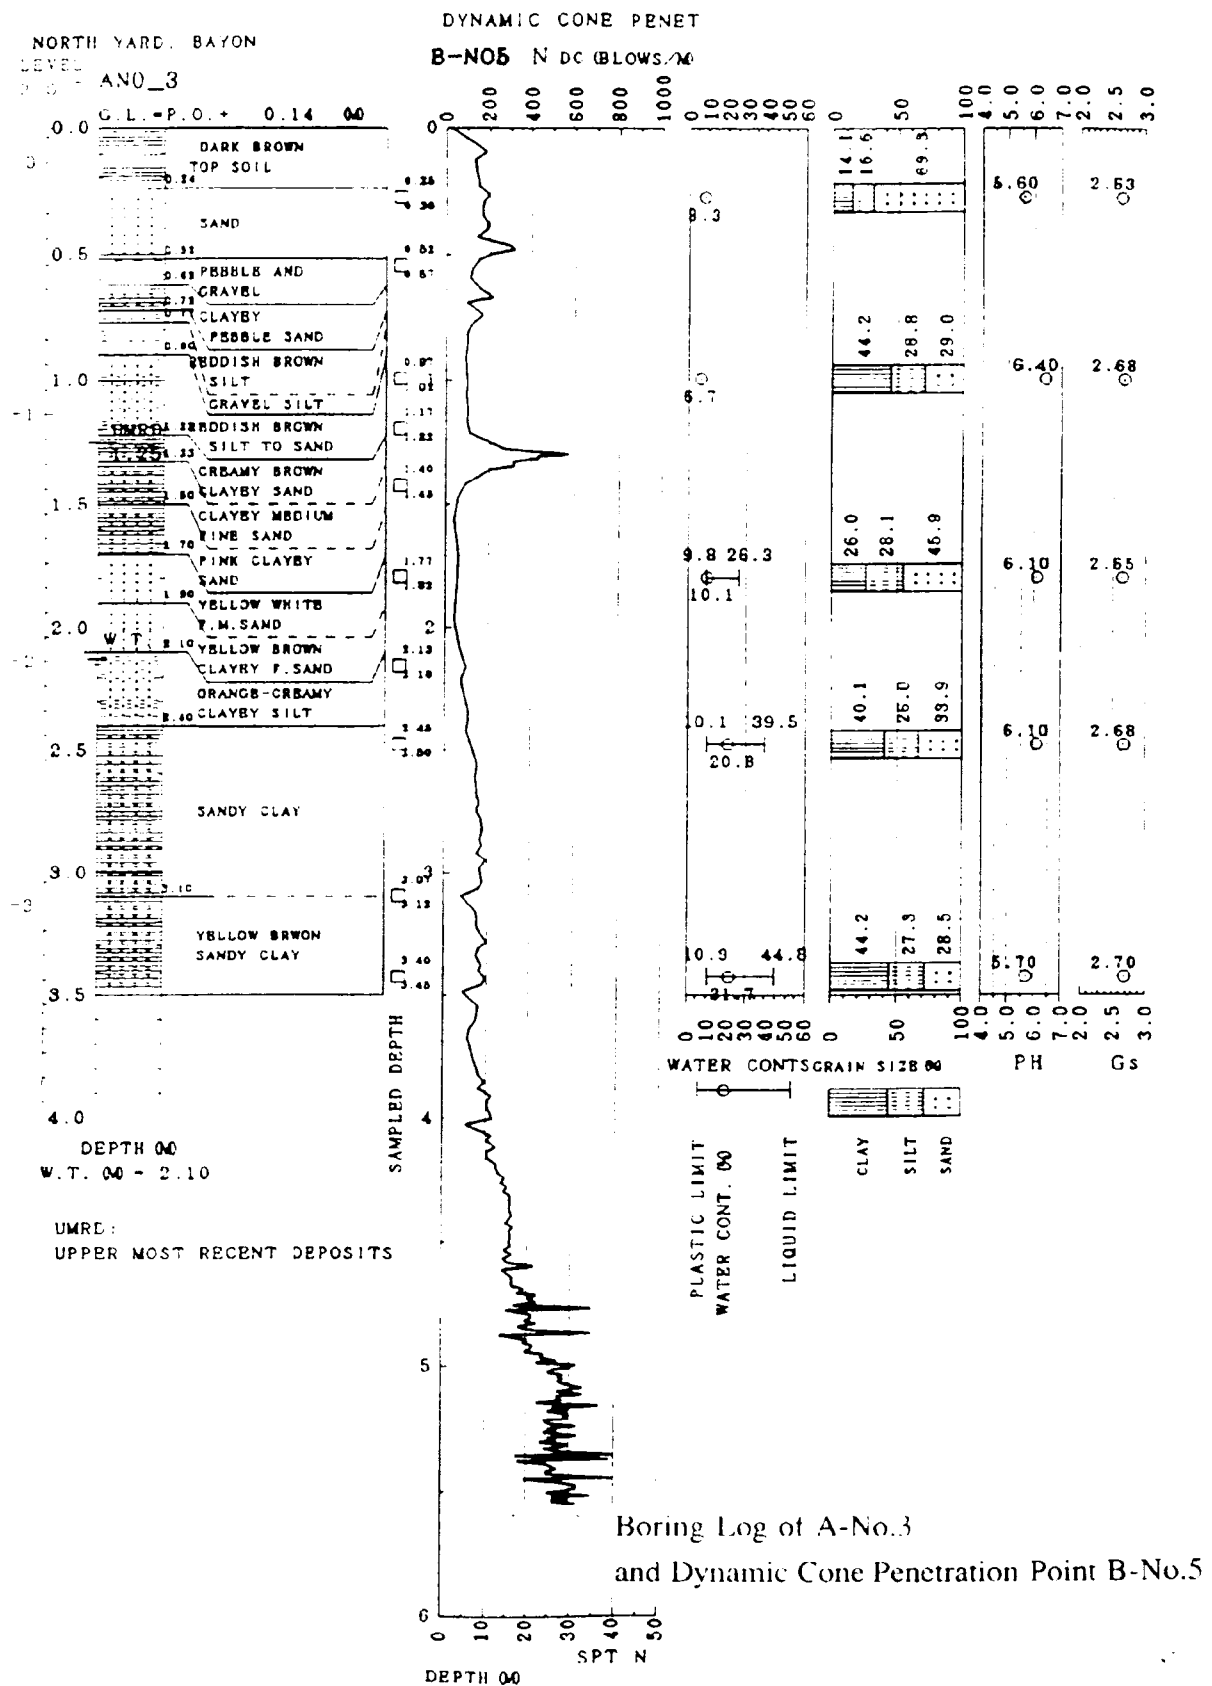
Fig.5-10 Results of Dynamic Cone Test (B.No-5) and Soil Characteristics for sampled at A.No-3

As shown in Fig.5-10, the upper surface soil is much more complicated than shown in the conventional drilling with SPT sampler. Alternations of sandy and clayey layers are predominant, which makes much easier horizontal flow of underground water. The rainwater infiltrates into ground may not only form vertical flow as well as horizontal one.

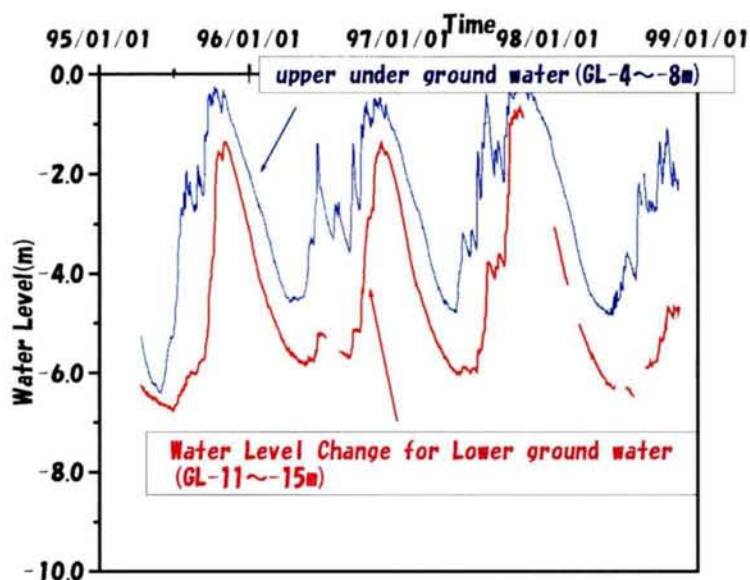
Fig.5-11 Seasonal change of level of underground water at Bayon site

The seasonal change of water level is seen as large as five to six meters, which may cause the drying and wetting of the top surface layer.

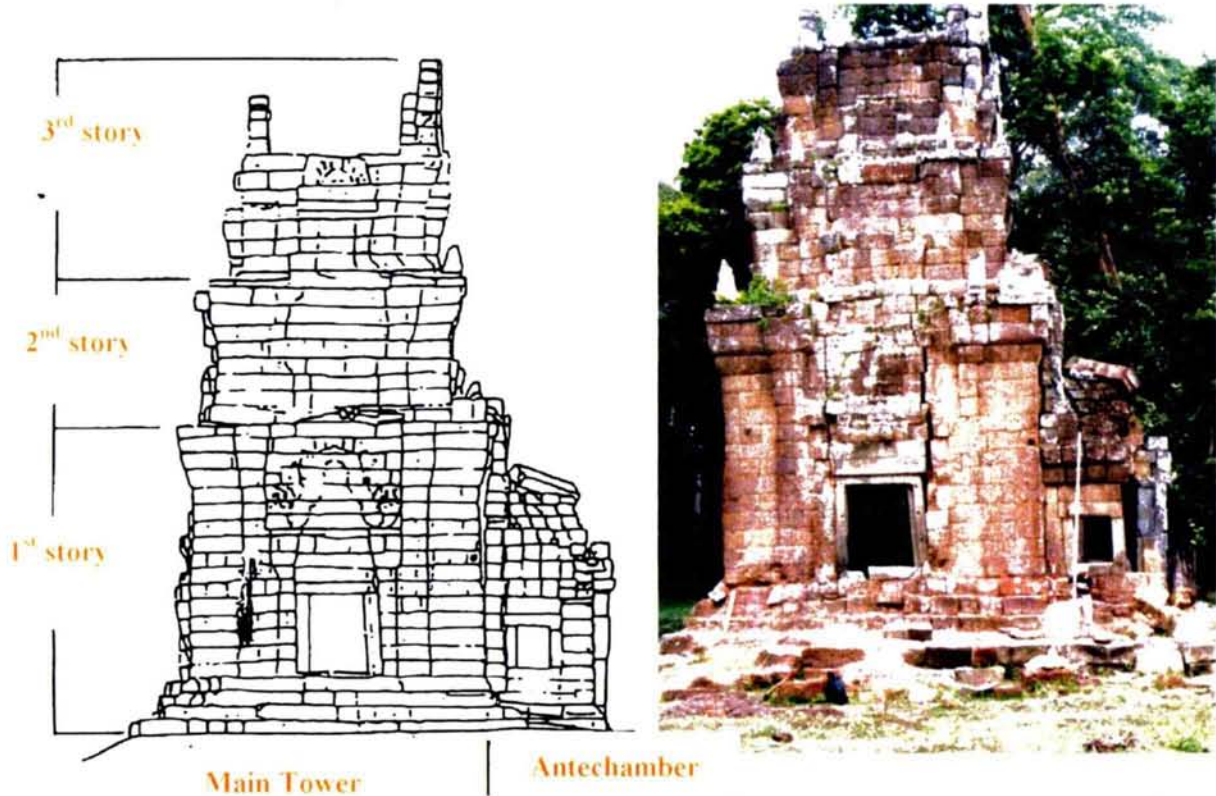
Photo 6-3 Side View of N1 Tower, Prasat Suor Prat

N1 Tower locates at the south of the North Pond of Prasat Suor Prat. The tower consists of mainly laterite blocks as main construction material. Sandstones were used at the entrance columns and lintels as well as decorative parts at each story

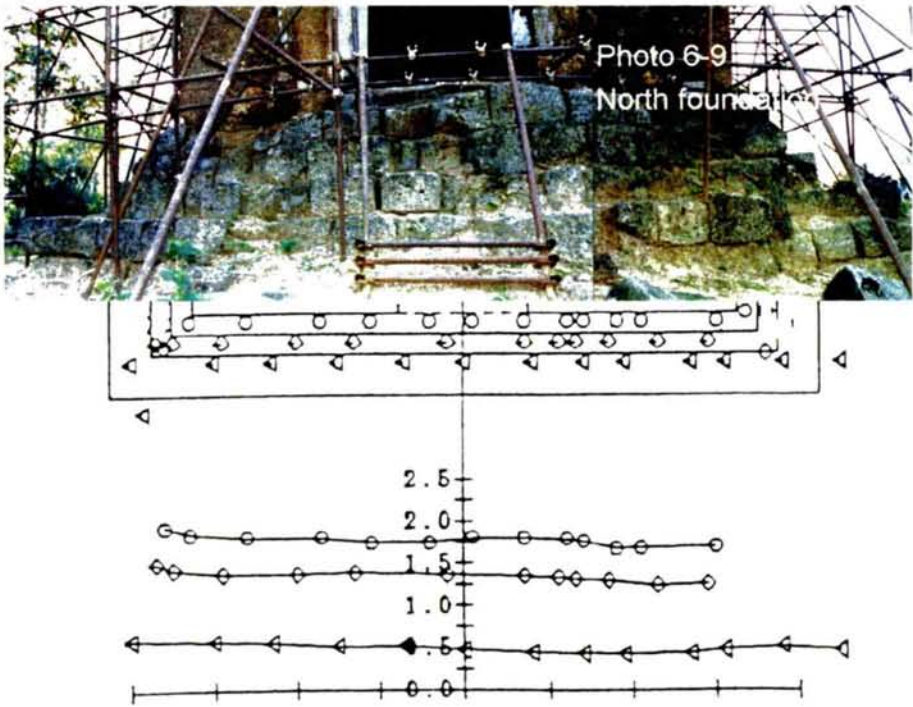
Fig.6-7 Height of each step of north wall

The maximum inclination of the foundation is north side foundation of about 40cm/10m, which is the same inclination direction as shown in Table 6-3. The inclination itself is one half of the inclination of the bottom beam of west opening.

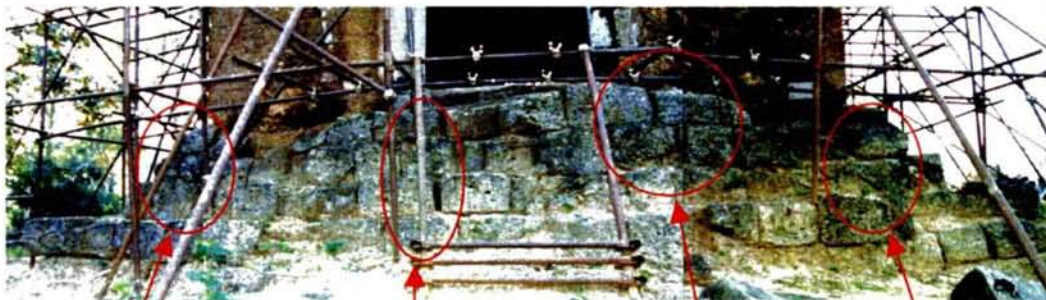
Photo 6-11  
North foundation

Any opening gap greater than 2mm is in block letter. The gap in any level shows larger value at the edges. At the base level, the large gap is found at the beneath of the edges of opening. This pattern of distribution of gaps suggests that the foundation is spreading horizontally, which have been caused by the ground movement beneath the foundation. The spreading portion of the grounds may be in the area where the larger stress had been concentrated by the tower structure. The deformations may be creeping characteristics in long term.

This phenomenon of horizontal spreading of the foundation is confirmed at every faces of the tower except the south face, where the measurement is not possible. The horizontal spreading was caused by several reasons.

The main cause might be due to horizontal outwards movement of compression of ground beneath the corner column where the load concentrated in long term. Wind force might have contributed to cyclic horizontal loading to the Tower, which additional horizontal displacements. The plant root intruded between laterite blocks had also widened the openings. The ground itself might have had expanded by some reason.

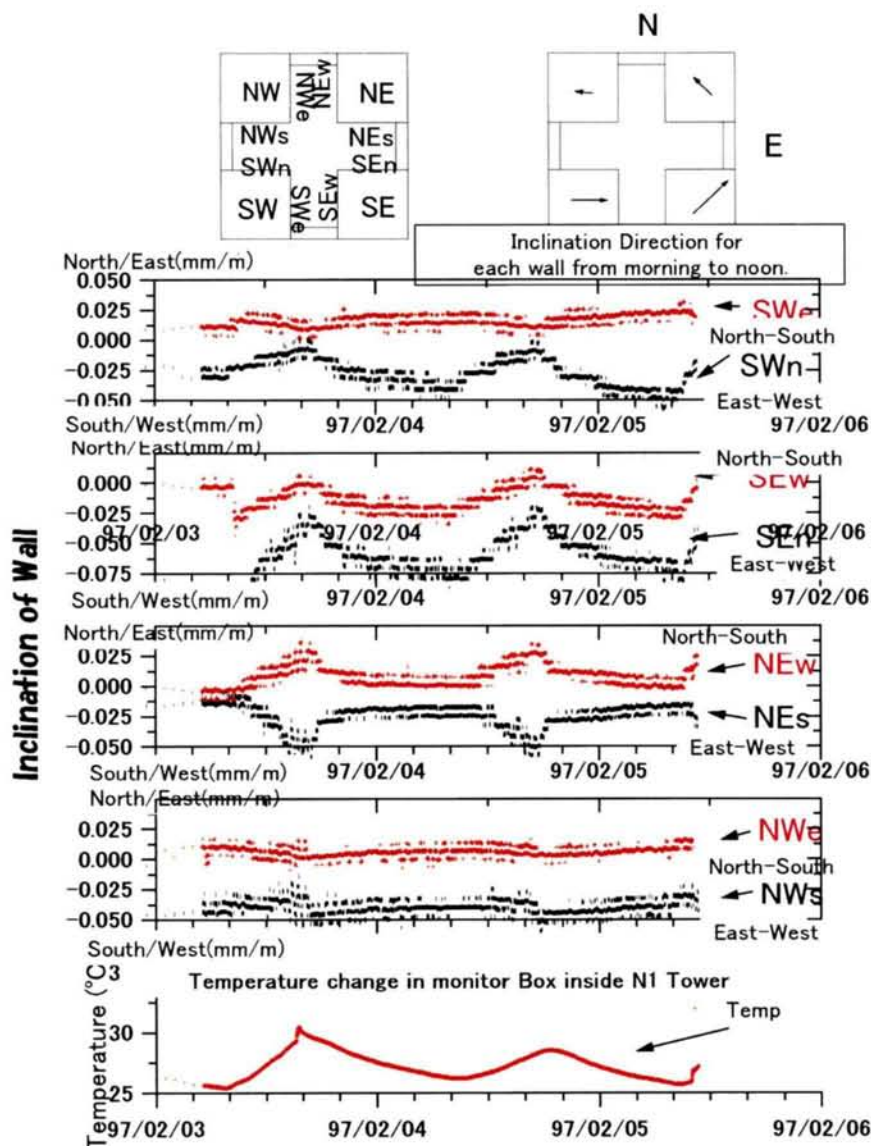
Fig.6-17 Daily change of inclination of wall inside N1 Tower, Prasat Suor Prat

We will discuss the daily change of inclination at first. Fig.6-17 shows inclination data of two and half days from February 3 to 5 of 1997. During this period, we selected the sampling interval as one minute and we will discuss some character of errors of the measured data. In the Fig.6-17, the upper four figures are inclination change of the corner walls and the bottom is temperature change at the

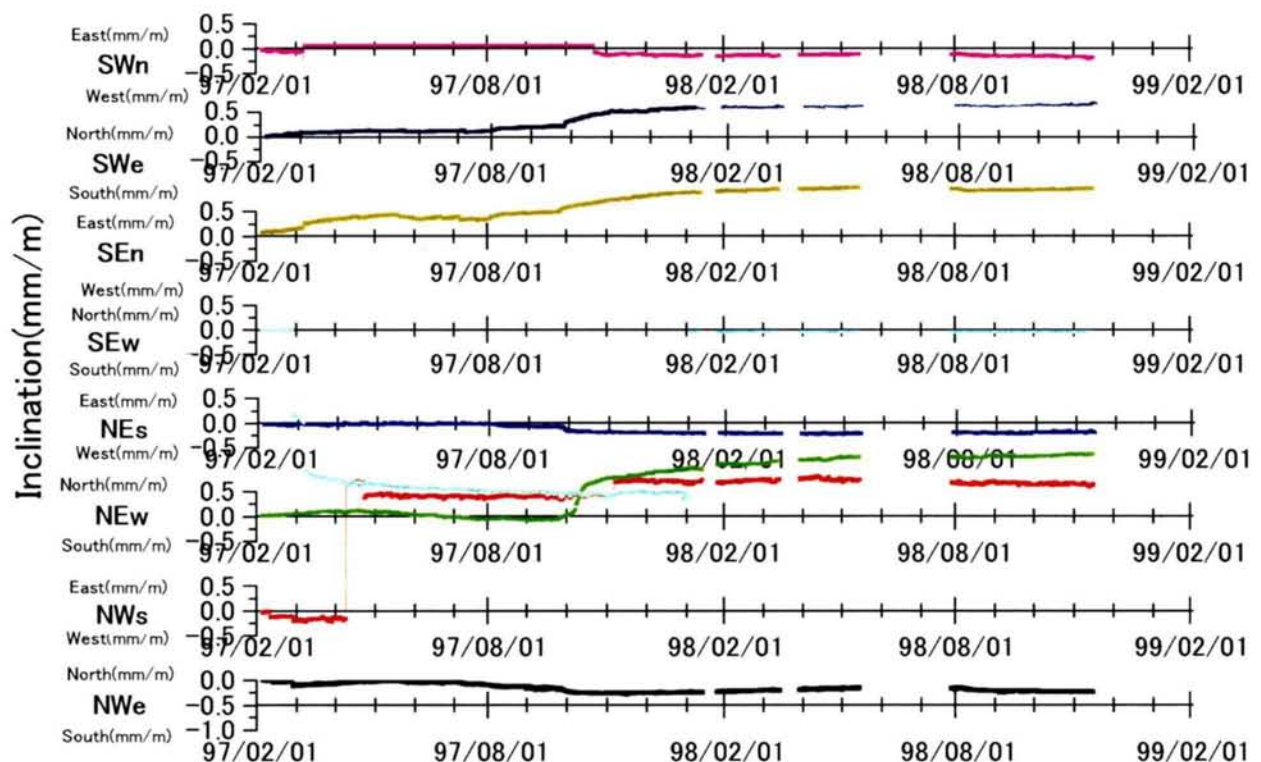
Fig.6-18 Inclination of stone column inside of N1 Tower, Prasat Suor Prat

Figs.6-18 and 6-19 show the inclination data of the Prasat Suor Prat for two years. These data, when the data were failed to retrieve, were skipped out. For some components like SEw the measured data shifted abruptly, which is considered due to repairing works of wire connection. These movements is difficult to understand, however, because of no significant change of other inclinometers and no meteorological change corresponding to this events, it is assumed as a meaningless phenomena.

In fall of 1997 there was a heavy rain when the embankment of moat near the west gate was failed at Angkor Wat. The inclinometer of N1 tower of Prasat Suor Prat had recorded movement of the tower caused by this rain. The inclinometer record of Fig.6-18 indicates the movements of the four walls as follows,

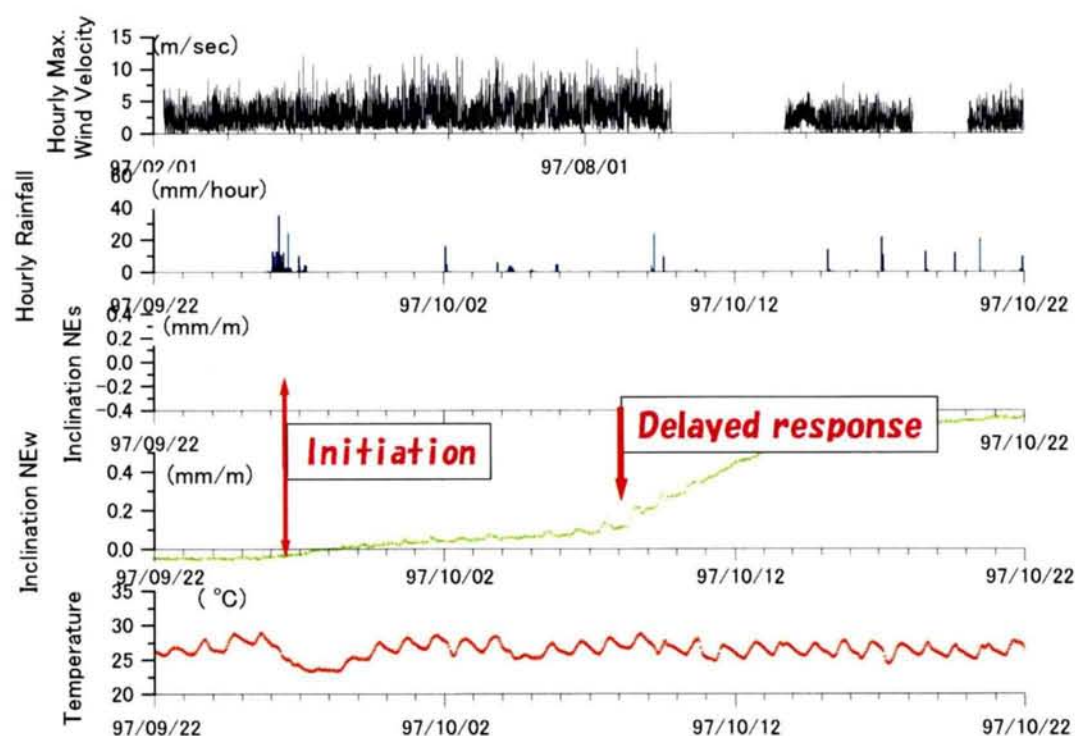
Fig.6-20 The Initiation of creep

Fig.6-20 shows the initial process of creep to start. It is of a great interest to see there is some delay of about 10days between the initiation of change and the delayed response time of creeping.

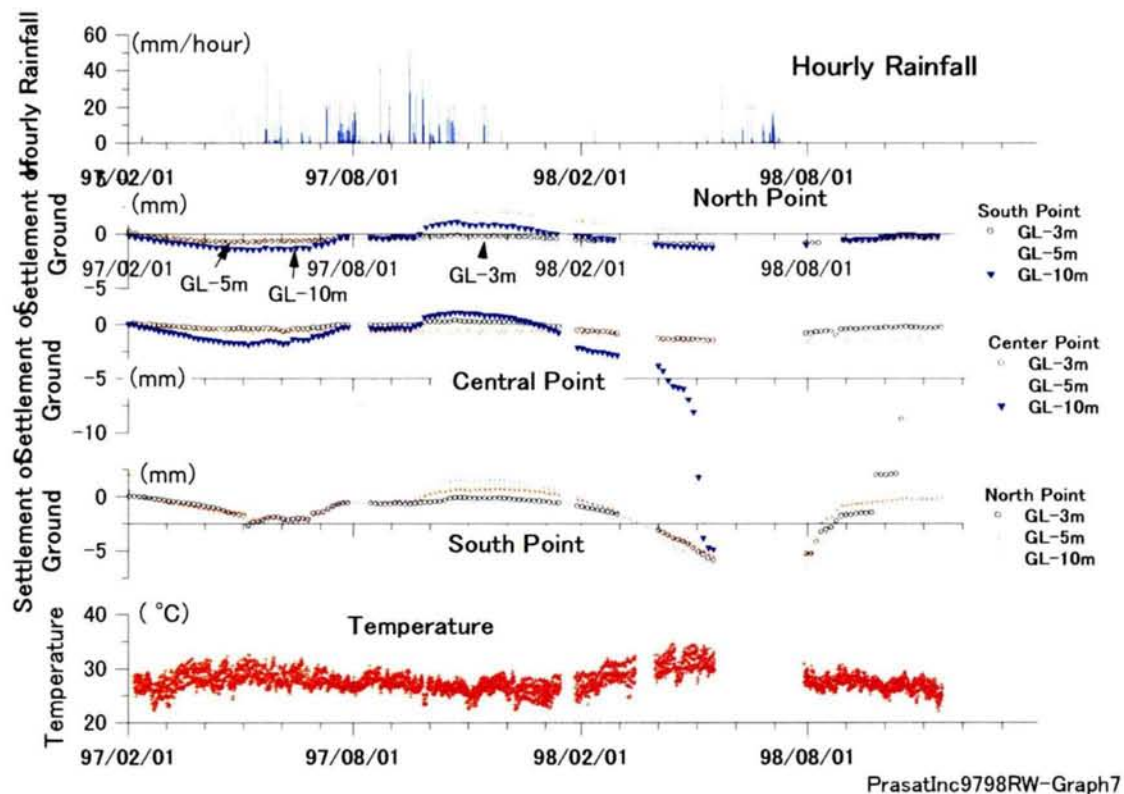
Fig.6-21 Settlement vs. Rainfall and Temperature at west of N1 Tower, Prasat Suor

Fig.6-21 shows the results of monitored ground settlement near N1 tower as well as rainfall and temperature change. The settlement was measured at three points of north, center, and south along a N-S line that is about 8m apart from center of N1 (see p.314, JSA Report 1997). North and south points are located at the extension lines of north and south edges of front room of the tower. Center point locates at the middle between the north and the south points. At each point, three different settlement pipes of three, five, and ten meter in length have been installed, which measures shrinkage or heaving between the ground surface and three different depths. Fig.6-21 shows the monitored results from February 1997 to November 1998 with a lack of data in summer 1998.

In dry season of 1997, the ground settlements of about 1-2mm were observed from February 1 to May 1, 1997.

After May when the rainy season starts, the settlement stops and heaving takes. The north point shows the largest settlement and swelling among three monitoring points. The settlements became rather stable during rainy season from August 1997 before the end of September when the heavy rain occurred. They have been activated due to the heavy rain that had caused the swelling of the ground. There are some common characteristics of these three points. In each point, the heaving from the ground surface to the shallowest 3m depth is almost negligible. However, the deeper points of 5m and 10m show much larger heaving after the heavy rain. This suggests that the water had infiltrated into the deeper layer, which became to expand to swell.

The maximum changes of ground settlement and swelling at three monitoring points are 3-4mm with an average of 2.13mm. After one year from 97/2 to 98/2, the maximum settlement residual is 2mm with an average of 0.39mm. It should be noted that the settlement during the later part of dry season showed about three times larger than the same period in the previous year of 1997, which may be due to rather high temperature in 1998 compared to those in 1997, which are also shown in Fig.6-23. Characteristics of settlements or swelling along the depth shall be treated in the next section.

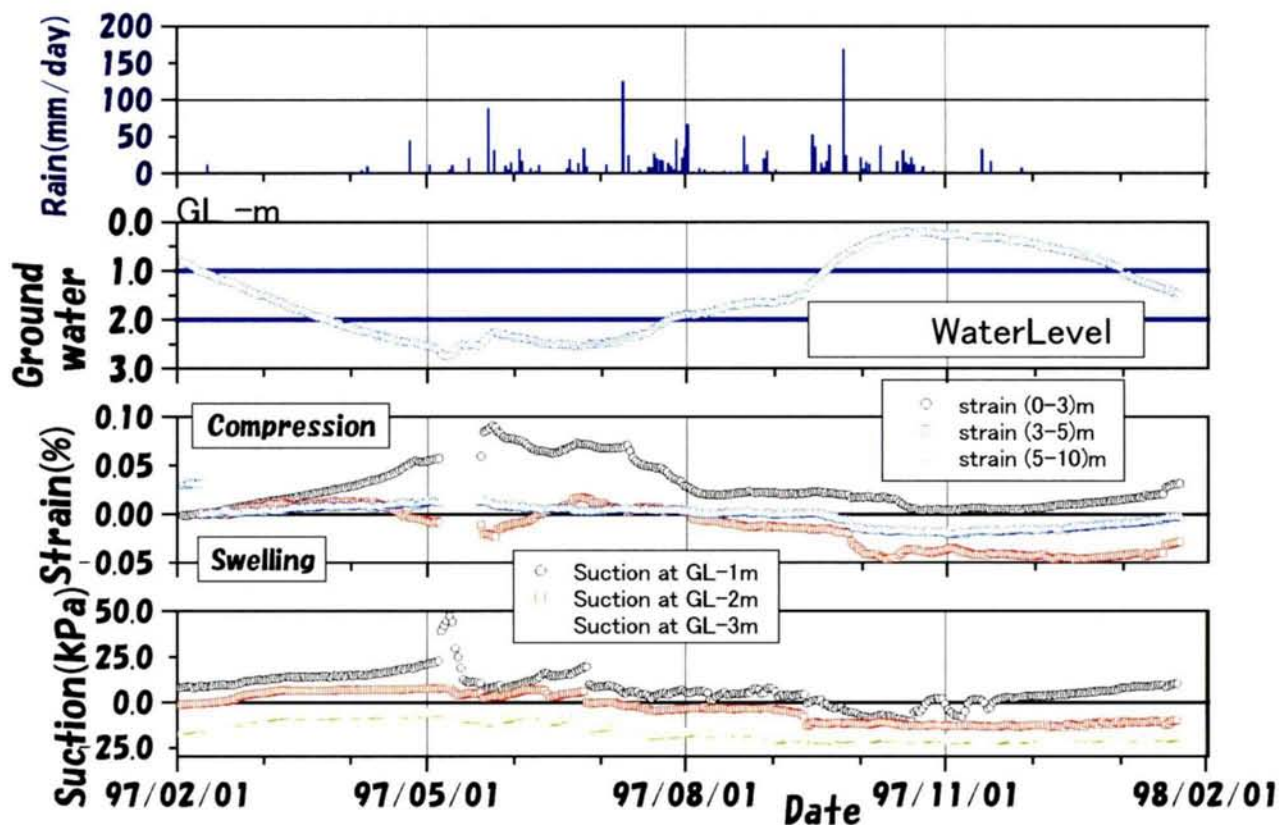
Fig.6-24 Rain, Ground Water, Strain of the Ground, and Suction

Fig.6-24 shows time histories of rain, ground water level, vertical strains, and suctions at north point. Vertical strains are computed by the differential settlement between GL-3, GL-5, and GL-10m divided by corresponding distances.

In dry season from February 97, suction pressure at GL-1m increased which corresponds the dewatering of underground water level. The compression of the ground from GL to GL-3m is found also increased.

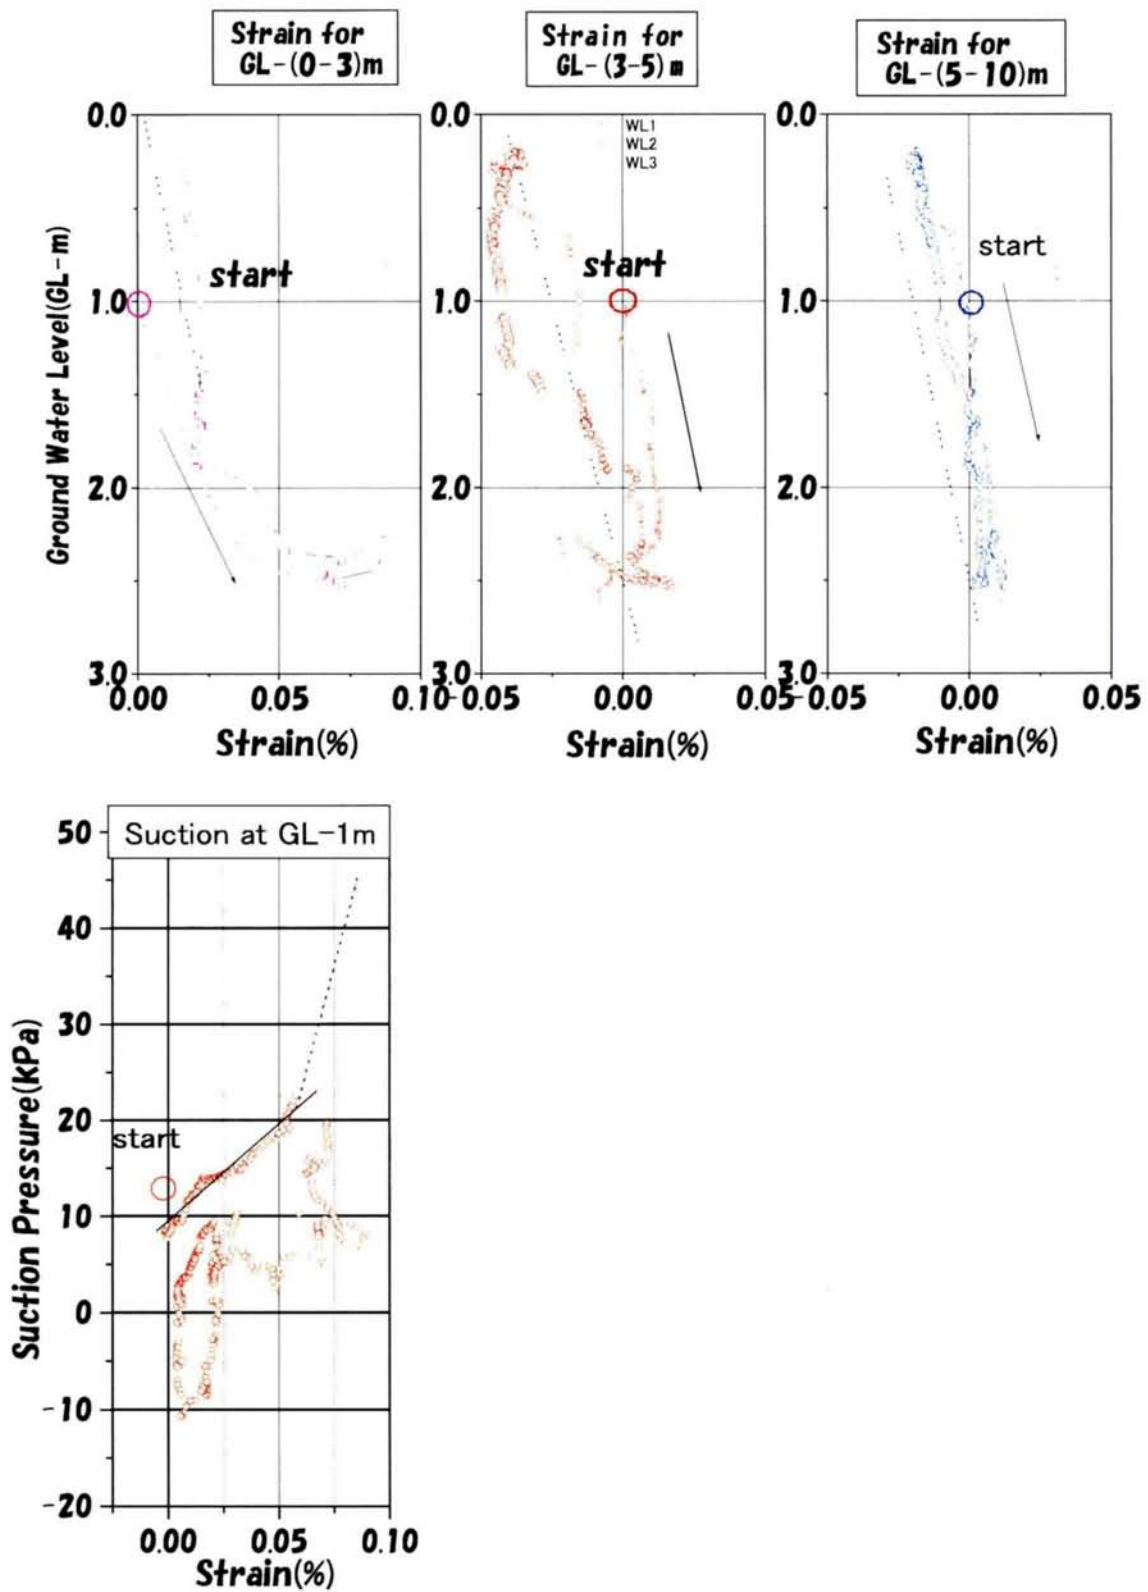
Fig.6-26 Vertical strain, Ground Water and Suction Pressure

Fig.6-26 compares vertical strains with ground water level and suction pressures. In general, the change of underground level induces the effective stress on the soils in the ground, which results in volume change of the ground.

The compressibility was found to increase with the depth. The apparent compressibility from effective stress change caused by water level and suction change were obtained as the same value of 40MPa.

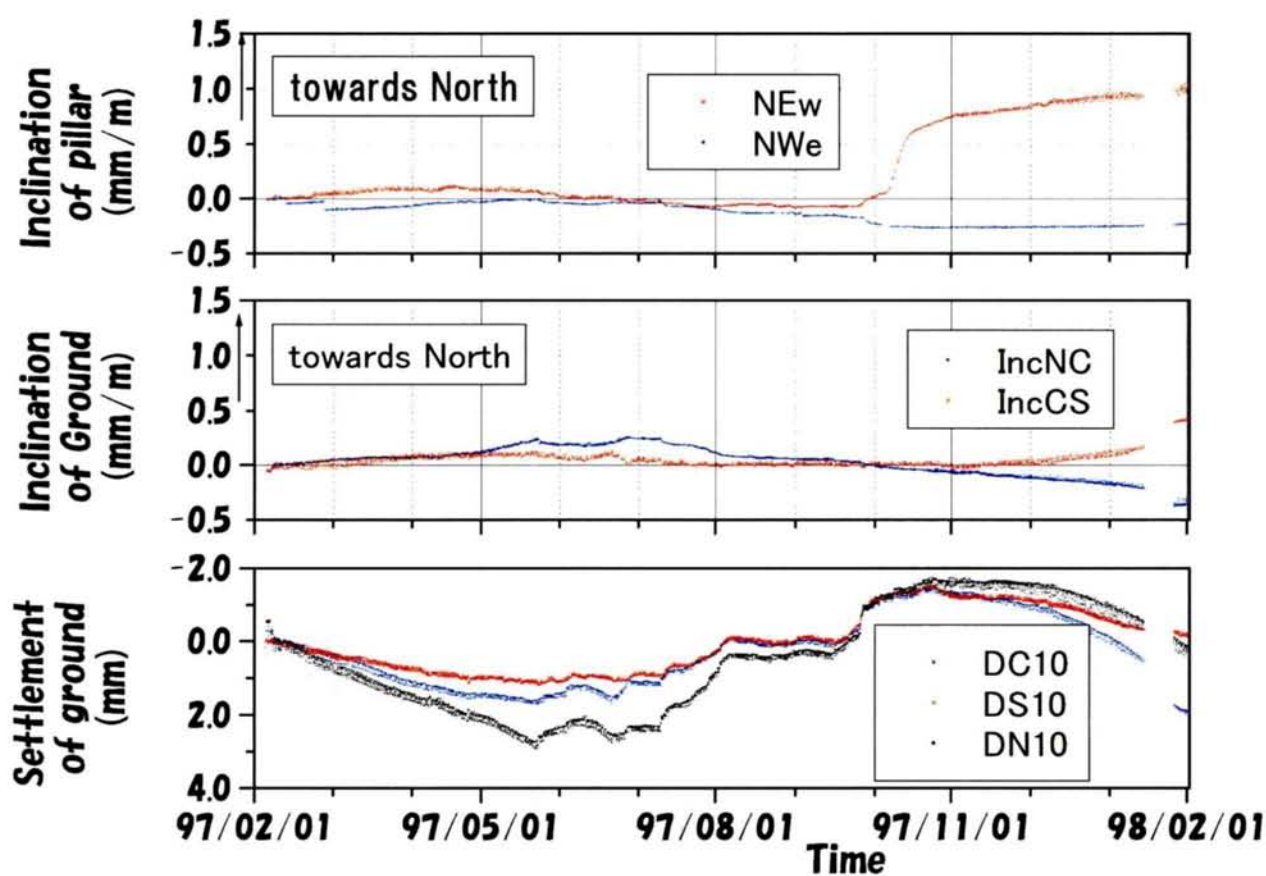
Fig.6.27 Settlements at north, center, and south points, inclination of masonry pillar at NE and NW corners, and inclination of ground

The inclination of masonry pillar takes the same tendency until the heavy rain in September. The increases of the inclinations of the pillars are found no relation with ground behavior.

If the tower inclination has been caused by the ground settlement/heaving, the inclination should be the same trends of the ground behavior.

The allowable settlement to keep the masonry structures from differential settlements is not known at this time. It is necessary to keep the present underground condition and to continue to monitor the ground water level as well as responses of the masonry structures to prepare any situations that may occur in the future.

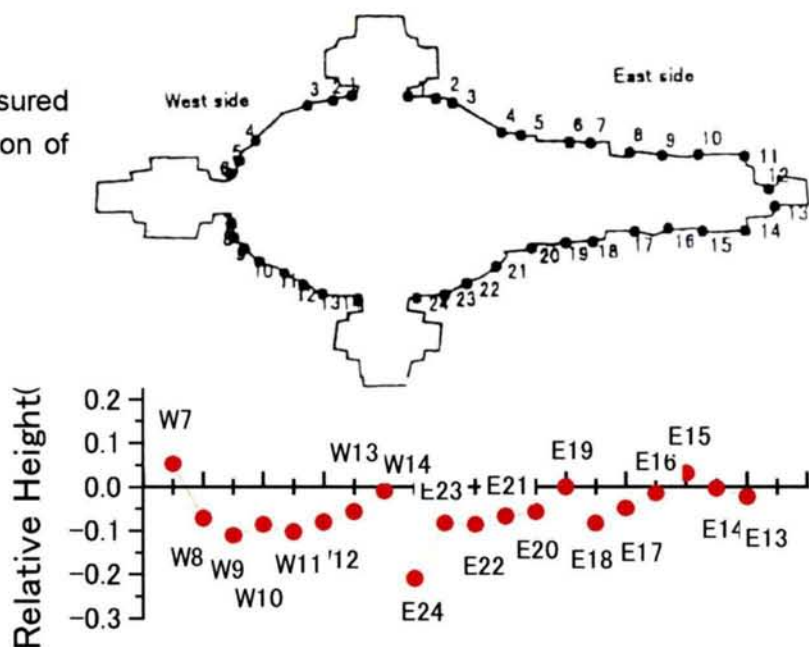
Fig.7-5 Relative Height of Basement around the main tower, Bayon on the Upper Terrace

The top and the bottom of Fig.7-5 show the height for northern and southern halves. It is understood that the western side of the tower is symmetrical in height. Both north and south subsided to the centerline. On the other hands, the eastern side of the tower is one sided.

The northern half (E1 to E4) is higher than southern counter part (E24 to E21) by about 0.25m. In the peripheral circle of the central tower, there are some portions of differential height or settlement. However, there is no definite trend to show one sided inclination.

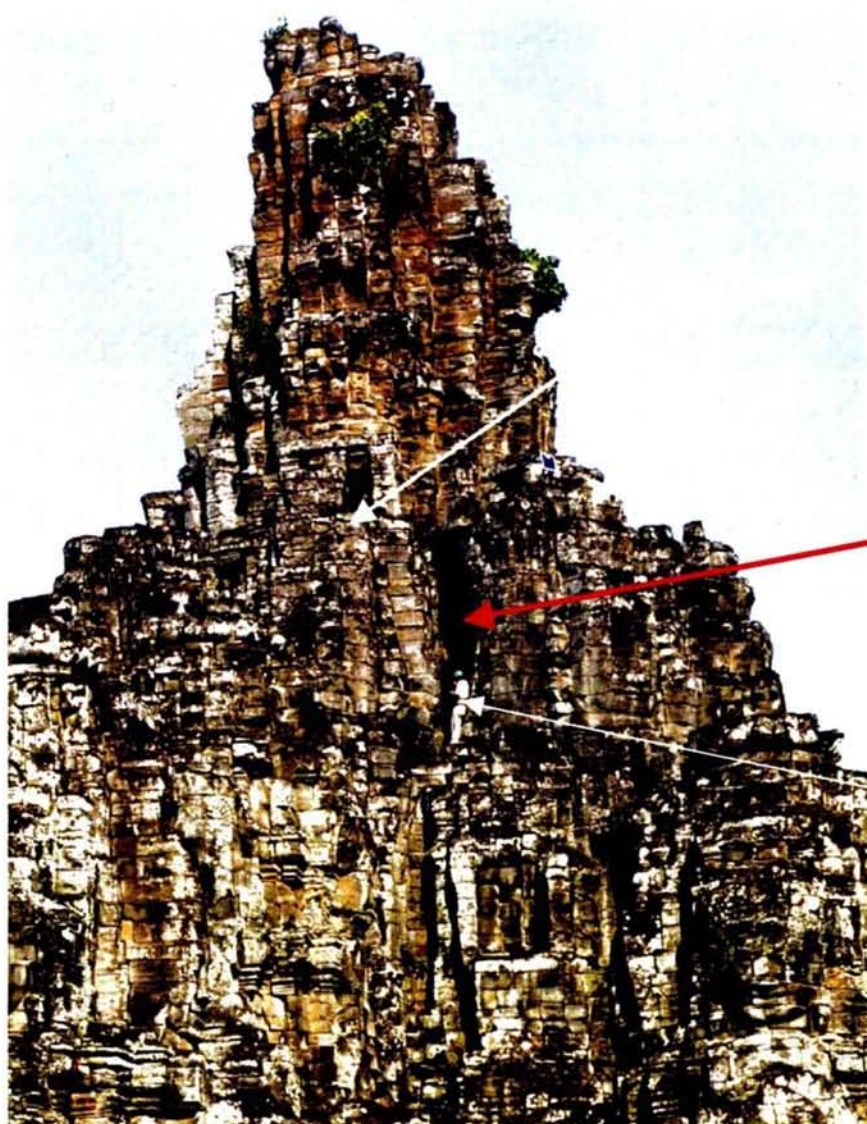
Photo7-6 Gallery of the Central Tower

Gallery opens at spaces  
between the Sub-Towers

There is a gallery within the central tower as shown in Fig.7-1, which surrounds the tower at a level of about +25m from the ground level. We can observe the present situation of the fall out process of the main tower. The Gallery is the space between the inner central tower and eight sub-towers. The Gallery is open at the spaces between the sub-towers as shown in Photo 7-6.

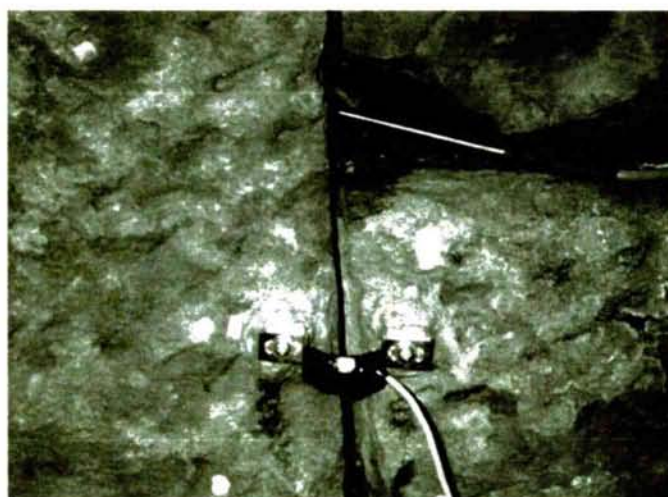
Photo7-12 Gap opening and temperature

Photo7-12 shows an example of installation of a gap sensor and thermometer at NW sub-tower.

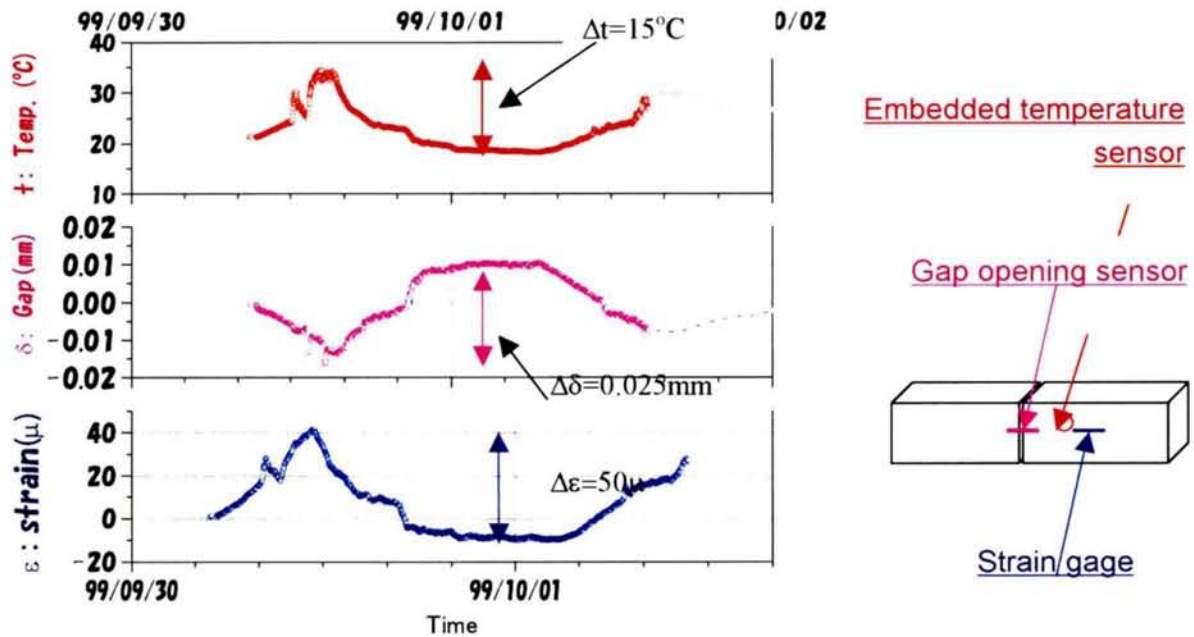
Fig.7-12 Temperature, strain of stone surface, and Gap opening

Fig.7-12 shows the relationship between strain of the stone surface, temperature inside the stone, and the gap opening of space between adjacent stone.

It was shown that the basic behavior of change of the gap between stones is the elongation or shrinkage of stones caused by temperature change.

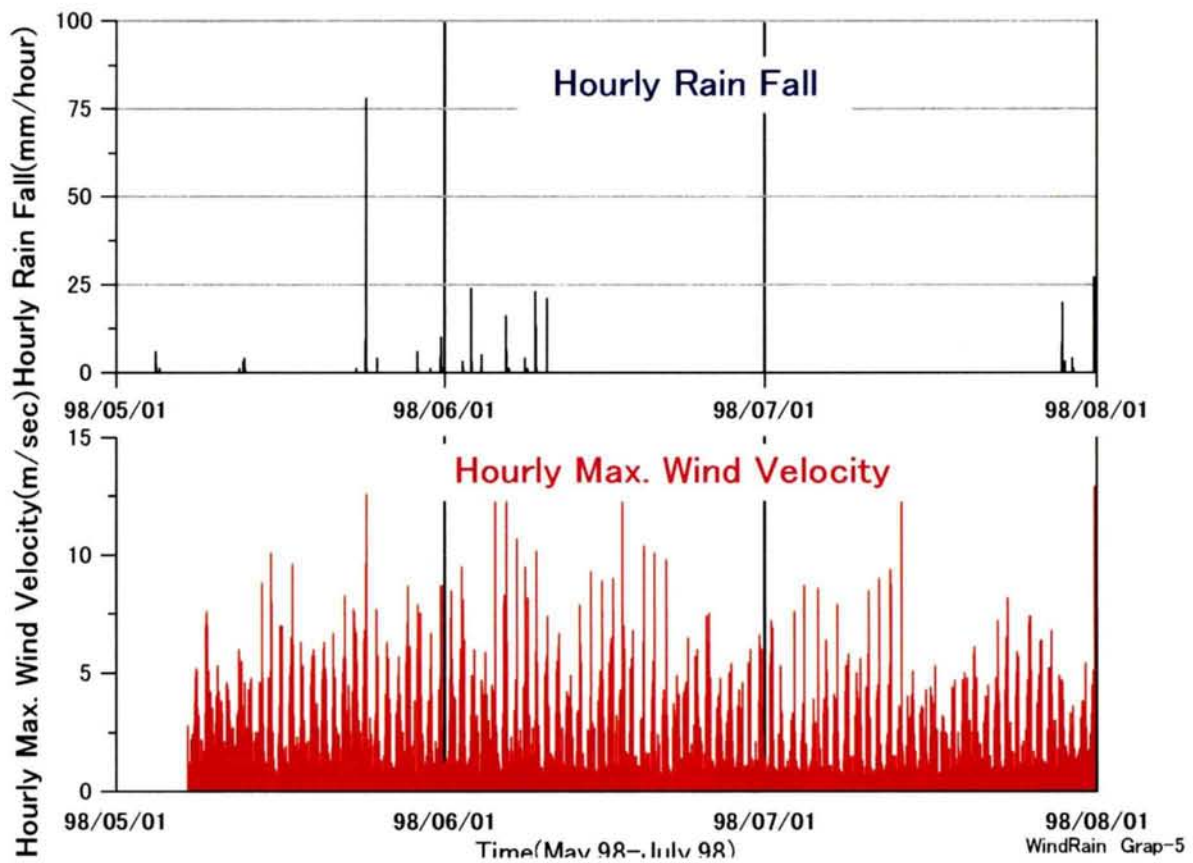
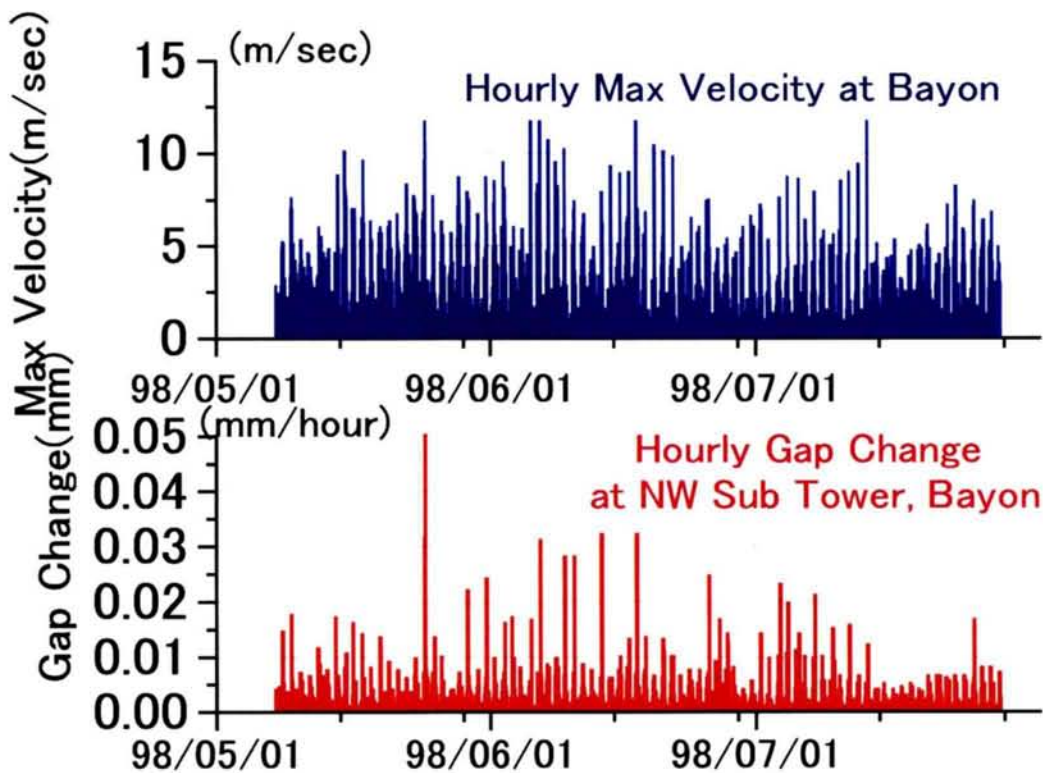
Fig.7-15  
Hourly rainfall  
and maximum  
wind velocity at  
Bayon from  
98/5/1to8/1

To see any relationship with other meteorological data, hourly rainfall and hourly maximum wind velocity monitored at the south library of Bayon are shown in Fig.7-14 and 10-15. These sudden changes are found concentrated rather in the rainy season from mid April as shown in Fig.7-9. Comparison between Fig.7-11 of gap opening and Fig.7-15 of hourly rainfall and wind velocity for three months after May 1998, it may be expected that the value of the hourly maximum wind velocity is more likely to be related than rainfall.

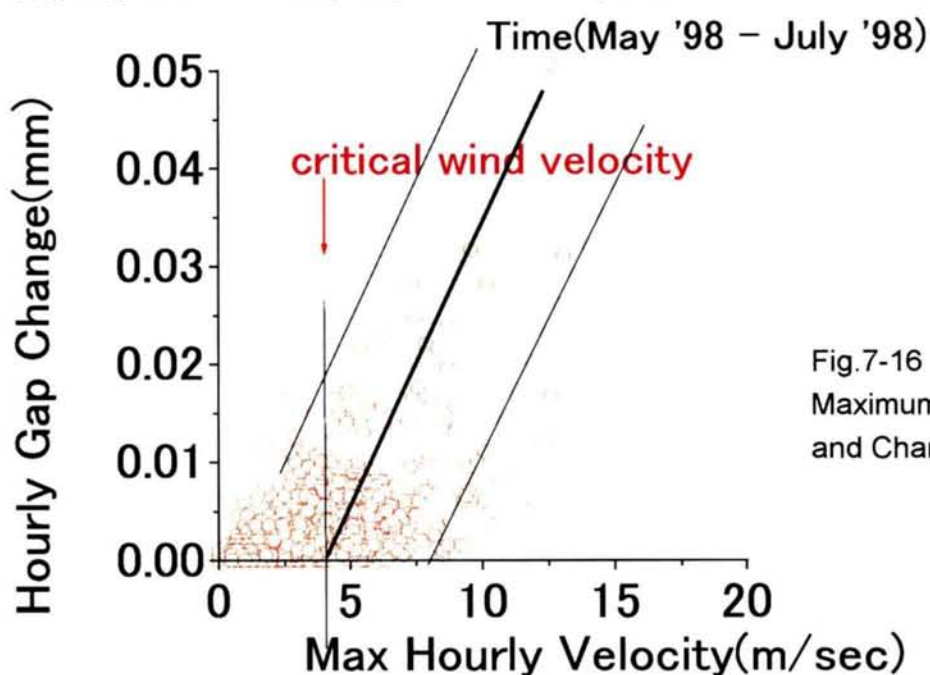
Fig.7-16  
Maximum wind Velocity  
and Change of NW Gap

Based upon the gap records, hourly gap changes are computed and shown in the upper part of Fig.7-16 with hourly maximum velocities. The relation between the hourly gap changes at NW point vs. the hourly wind velocities in the same time range shown in the lower part can be understood that the stronger wind velocity had triggered the larger sudden gap change in the same hour duration. We may define a critical wind velocity over whose value large sudden gap changes are observed. The critical wind velocity at NW point is about 4km/sec.

As mentioned above, gap opening responds with strong wind velocity instantly. However, the sudden gap change does not always accumulate in the following period. For example, the gap change at NW point suddenly increased at the strong wind always takes the opposite direction and has returned to the original gap opening after 2-3 days. On the other hand, these sudden changes at W points stay as shifted values. The rebound response to return to the original position may be due to mechanical stability of the stone tower. Strong wind causes a small displacement between stone elements, which is basically a result of response of the tower structure against wind. In 1994, the micro-tremor of several structures in Angkor area were measured (JSA report, 1995) and revealed the existence of the natural period for masonry structures and the related mode of movement. The micro-tremor of the main central tower should also be monitored to relate the gap displacement with the structure itself as well as wind force

Monitoring of open/close of gap between stone blocks revealed that the strong wind has resulted in non-reversal type movement, which may cause lean-out horizontal displacement of the masonry column.

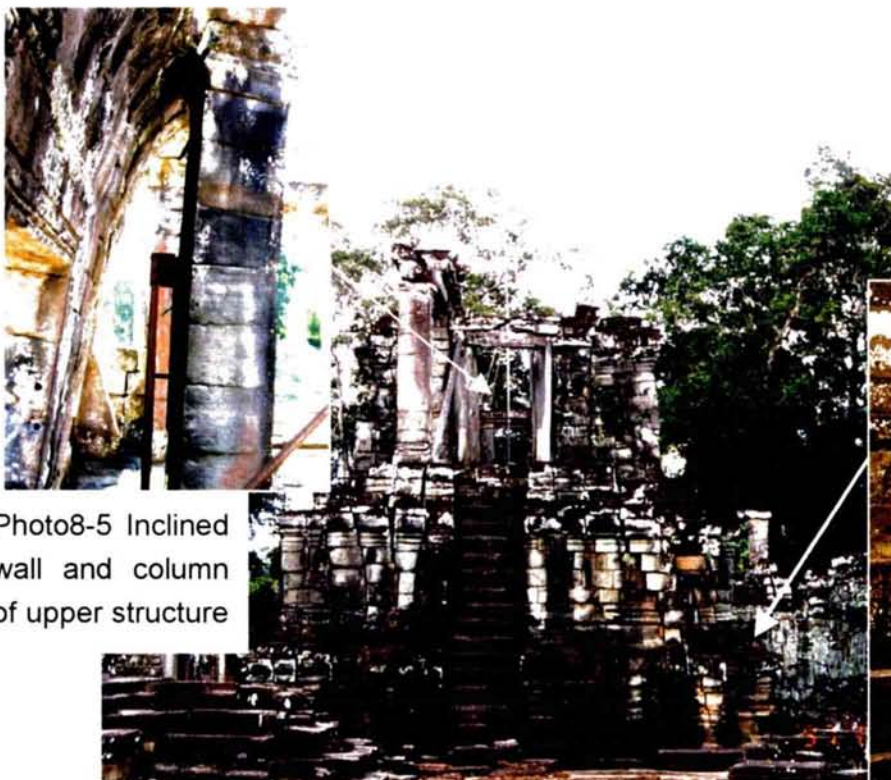
Photo8-5 Inclined wall and column of upper structure

The walls of upper structure are heavily inclined towards inside (Fig.8-5). The boundaries of porches and the main structures at both ends are found settled and have become the lowest level. Lintels of porches have been struted against structural collapse.
